# mesa-az Transportation Advisory Board Report

Date:	January 16, 2018
To:	Transportation Advisory Board
From:	Ryan Hudson, Senior Transportation Engineer
Subject:	Efficacy of Various Traffic Calming Measures in Mesa

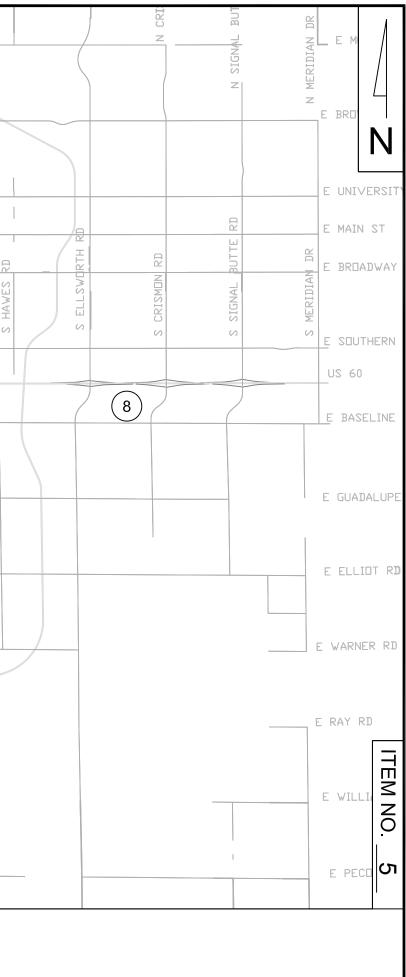
## FIGURE 1: LOCATION MAP

₩ M(	CKELL	.IPS	RD 101 100		JOL RJ				4			E ERDWN RD	
V UNIVI	ERSI <u>T</u>	Y DI	R 3		SCHOOL			(5)				E UNIVERSITY DR	
	W MA	AIN	ST		S ALM	NU			10			E MAIN ST	
/ BROAD	_				2	S COUNTRY CLUB	S MESA DR	S STAPLEY DR	Ľ.	S LINDSAY RD		A VAL VISTA DR A VAL VISTA DR	S HAWES RD
7	US	60					(11)			US 60			
				STUDY	LOCATI	ONS	/	//	FEATU	RE/CHANGE		E FASELINE RD	
	1	BR	ROADWAYR	d - Alma	SCHOOL	RD T	O WESTW	/OOD	SCHOOL	ZONE FLASHE	R		
	2	AL	MA SCHOOL	RD - BR	OADWAY	RD T	o alma mi	EADOWS	SCHOOL	ZONE FLASHE	R	E GUADALUPE RD	
	3	MA	Y - UNIVERS	SITY DR T	O RIO SA	LADO	PKWY			DSFS		E ELLIDT RD	
	4	МС	CLELLAN RD	- HARRIS	S DR TO G	GILBEF	RT RD		SPEEI	O CUSHIONS			
	5	8Т	H ST - MESA		HORNE				SPEEI	O CUSHIONS		E WARNER RD	
	6	su	INNYVALE - I	BROADW	AY RD TO	D DEL	TA AVE		SPEEI	O CUSHIONS		LOUP 202/SAN TAN FWY	
	7	54	TH ST - SOL	ITHERN A	VE TO SU	JNNYV	/ALE		SPEEI	O CUSHIONS		E RAY RD	
	8	96	TH ST - BAS	ELINE RE	) to Idah	O AVE			SPEEI	O CUSHIONS

9	2N	D ST - ALMA	SCHOO	L RD TO W	WEST	WOOD		SPE	ED HUMP		E WILLIAMS FIELD RD	
	10	15	T PL - 1ST S	T TO LAZ	ZONA AVE				SPE	ED HUMP			
	11	нс	OVER AVE	- PIMA TC	) PASADE	NA			SPE	ED HUMP

See *Figure 1* for a description of all study locations as well as the respective speed mitigation feature implemented at each location.
