Historic Preservation City of Mesa

Thursday, February 05, 2026

14 PRESERVATION BRIEFS

New Exterior Additions to Historic Buildings: Preservation Concerns

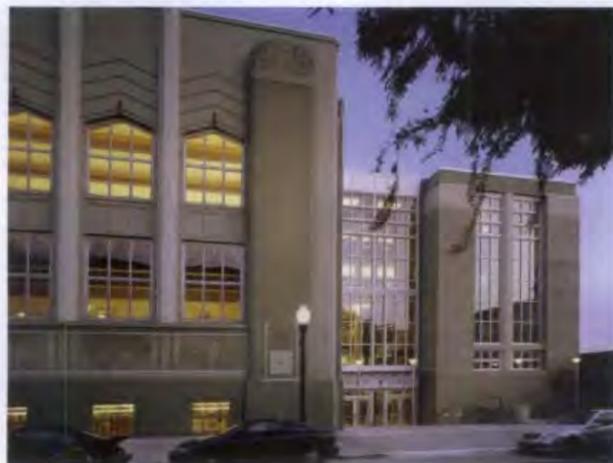
Figure 1. The addition to the right with its connecting hyphen is compatible with the Collegiate Gothic-style library. The addition is set back from the front of the library and uses the same materials and a simplified design that references, but does not copy, the historic building. Photo: David Wakely Photography.

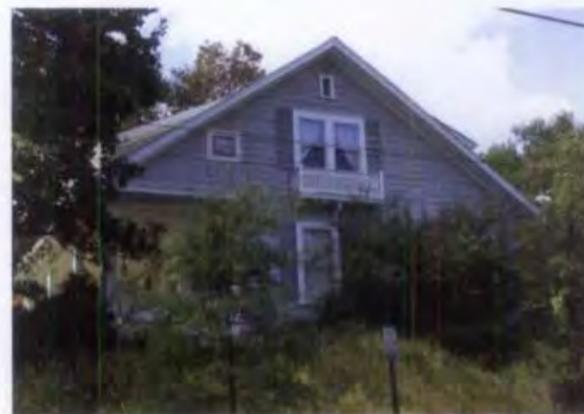
Figure 18. The expansion of a one- and one-half story historic bungalow (left) with a large two-story rear addition (right) has greatly altered and obscured its distinctive shape and form.

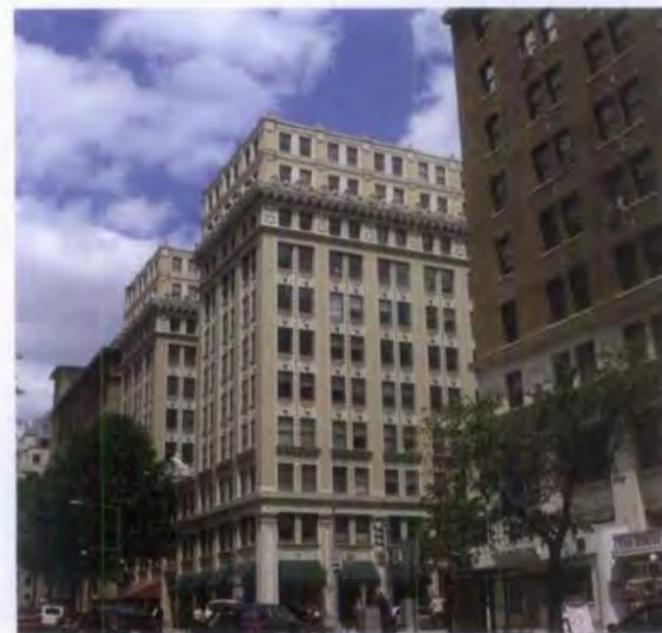
Figure 19. The upper two floors of this early-20th century office building were part of the original design, but were not built. During rehabilitation, the two stories were finally constructed. This treatment does not meet the Standards because the addition has given the building an appearance it never had historically.

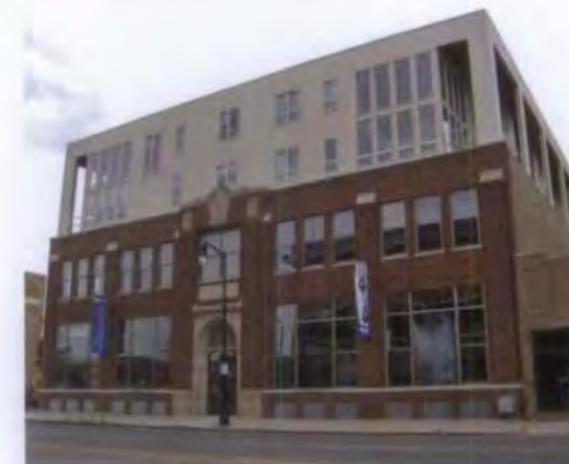
Figure 20. The height, as well as the design, of these two-story rooftop additions overwhelms the two-story and the one-story, low-rise historic buildings.

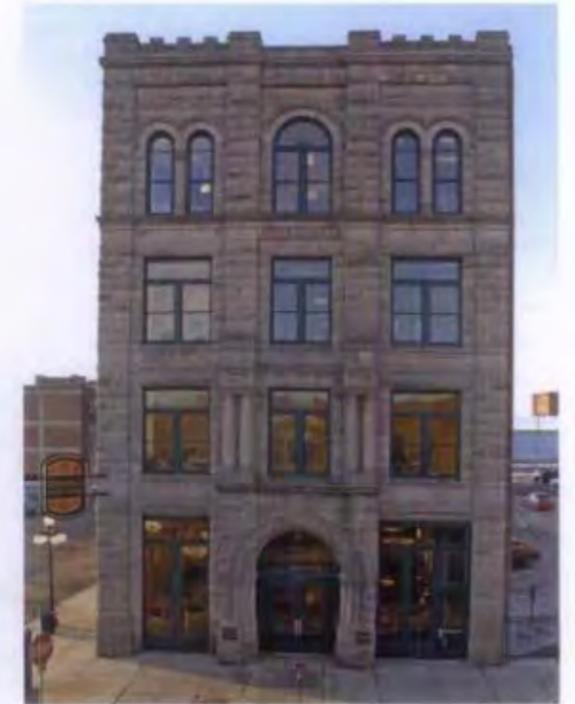
Figure 27. Although the new brick stair/elevator tower (left) is not visible from the front (right), it is on a prominent side elevation of this 1890 stone bank. The compatible addition is set back and does not compete with the historic building. Photos: Chadd Gossmann, Aurora Photography, LLC.

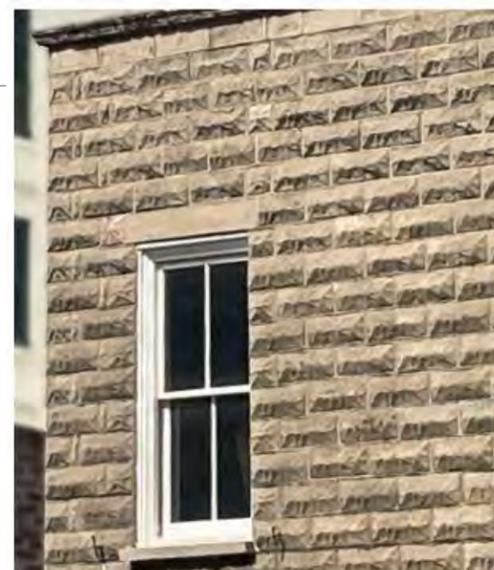
Figure 2a. Casting concrete blocks to mimic quarried stone was a popular late 19th- to mid 20th-century technique. Concrete masonry units could be completed by local craftsmen, saving time and shipping costs. Photo: John Sandor, NPS.

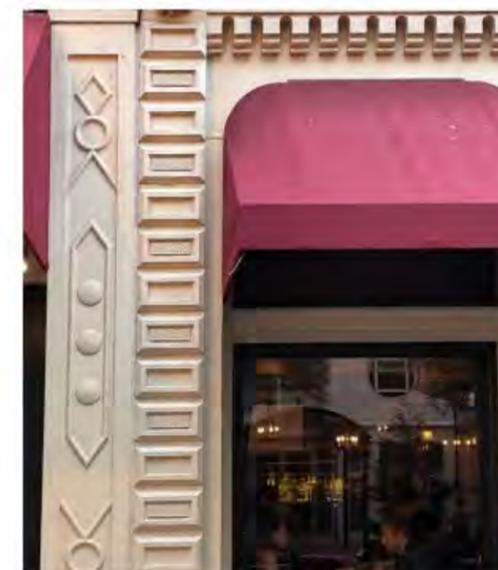
Figure 2b. The 19th century also produced a variety of metal products used to imitate other materials. Across the country, cast iron was used in storefronts to imitate stone. Photo: John Sandor, NPS.

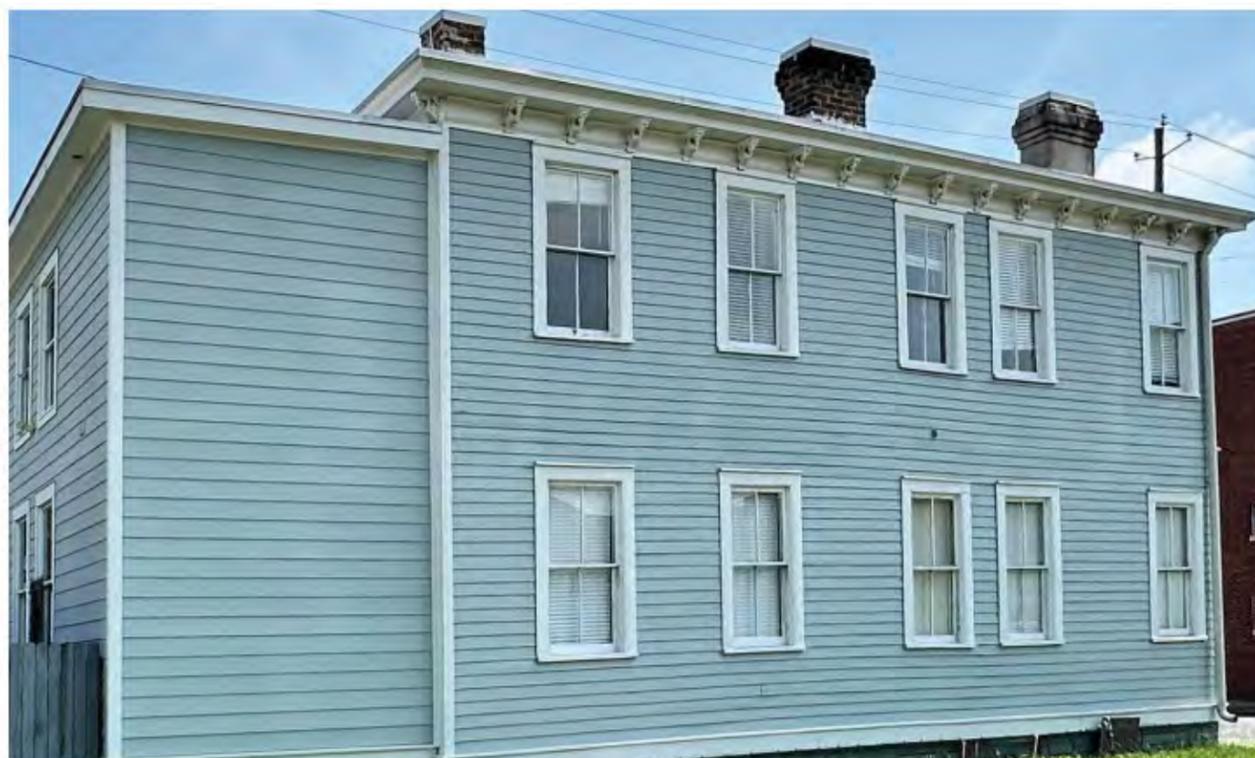
Figure 7. A new addition replaced non-historic construction on the rear elevation of this building. Fiber cement gives the addition a compatible appearance without replicating the exposure for thickness of the historic siding. Photo: Ward Architecture + Preservation.

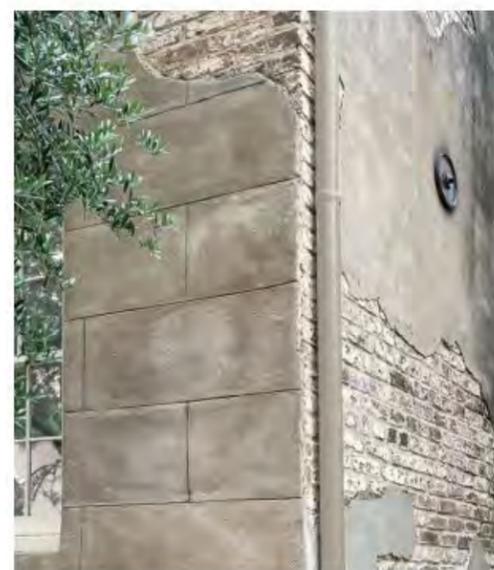
Figure 2c. Stucco has been used to imitate a number of building materials for many centuries. Seen here, stucco was applied to a brick structure and scored to represent a stone façade. Photo: John Sandor, NPS.

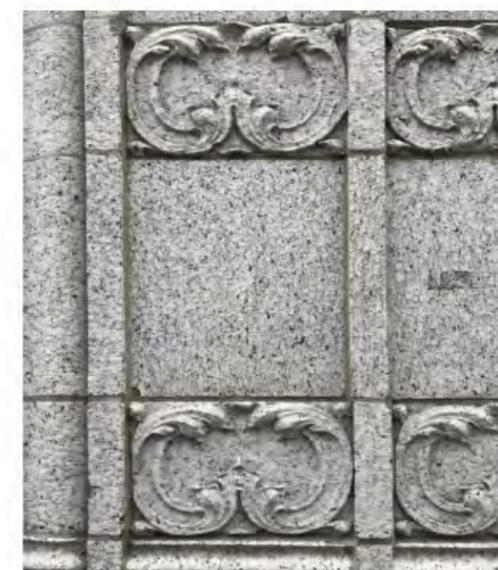
Figure 2d. Terra cotta gained popularity in the late 19th century as a cheap and lightweight alternative to stone. Glazing techniques allowed the blocks to imitate a variety of natural stone materials. Photo: John Sandor, NPS.

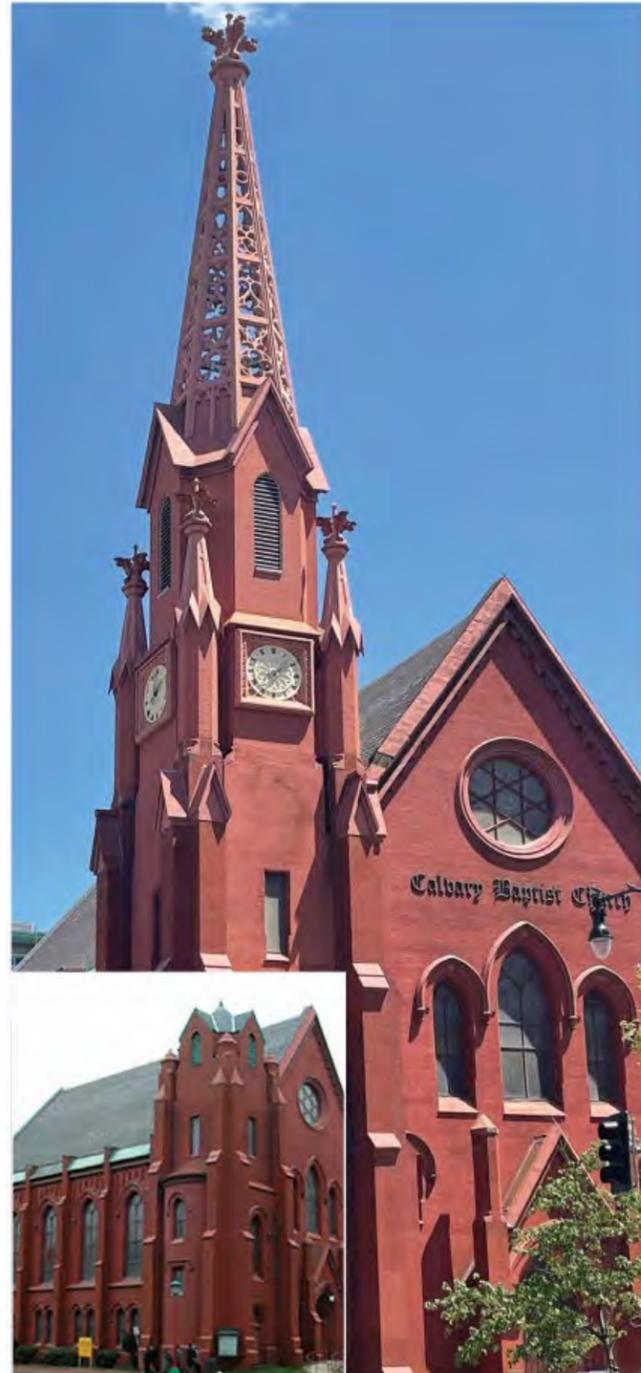
Figure 8. A long-missing cast-iron steeple was reconstructed in aluminum and fiber-reinforced polymer (FRP). Photo: John Sandor, NPS, Inset: Quinn Evans.

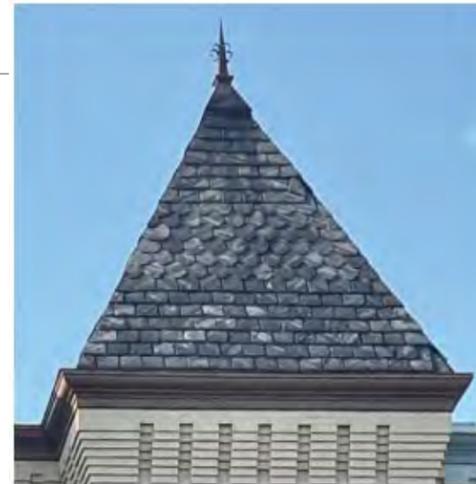
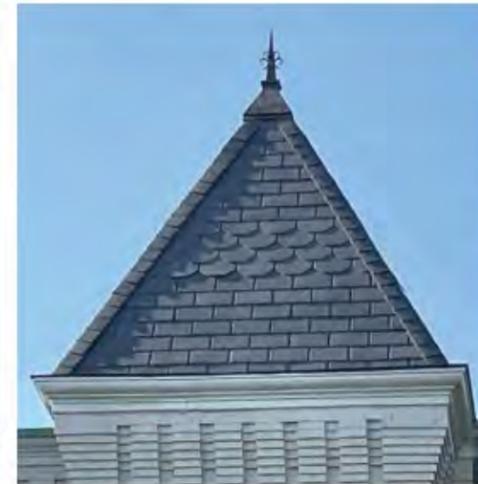
Figure 10. Polymer slates offer a choice of shapes but not sizes, limiting their ability to achieve a good visual match for some historic slate. With the size of the polymer slates (right) being nearly twice that of the historic slates (left), the scale of the entire feature is incompatibly altered. The molded edges of this material, which contribute to its ability to replicate slate, would be lost if each shingle was resized by cutting. Photo: John Sandor, NPS.

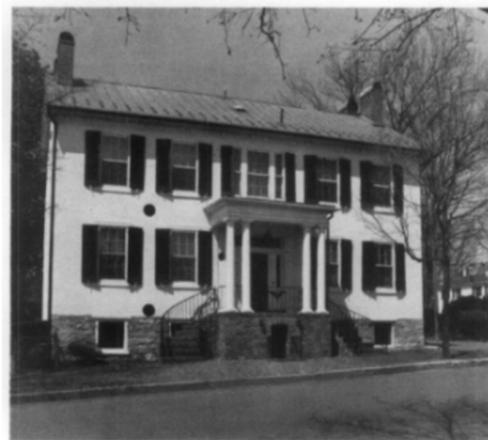
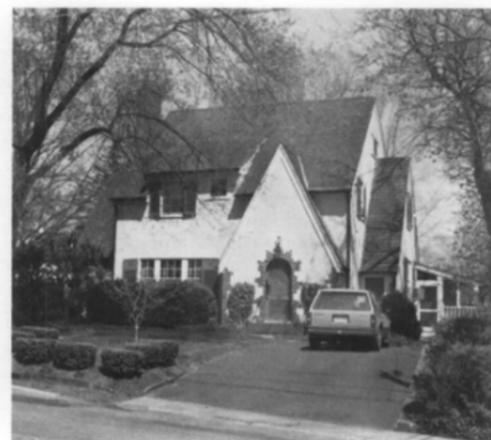
Fig. 1. These two houses in a residential section of Winchester, Virginia, illustrate the continuing popularity of stucco (a) from this early 19th century, Federal style house on the left, (b) to the English Cotswold style cottage that was built across the street in the 1930's. Photos: Anne Grimmer.

Stucco has been used since ancient times. Still widely used throughout the world, it is one of the most common of traditional building materials (Fig. 1). Up until

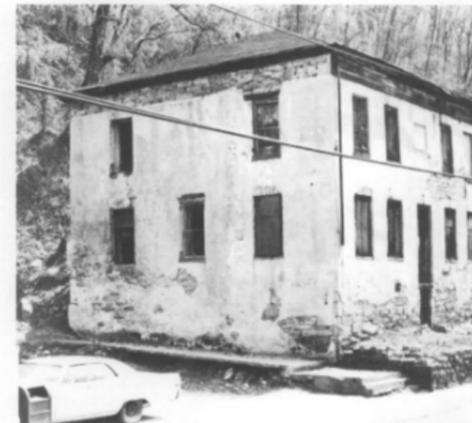
Fig. 7. Patches of stucco have fallen off this derelict 19th century structure exposing the rough-cut local stone substrate. The missing wood entablature on the side and the rough wood lintel now exposed above a second-floor window, offer clues that the building was stuccoed originally. Photo: National Park Service Files.

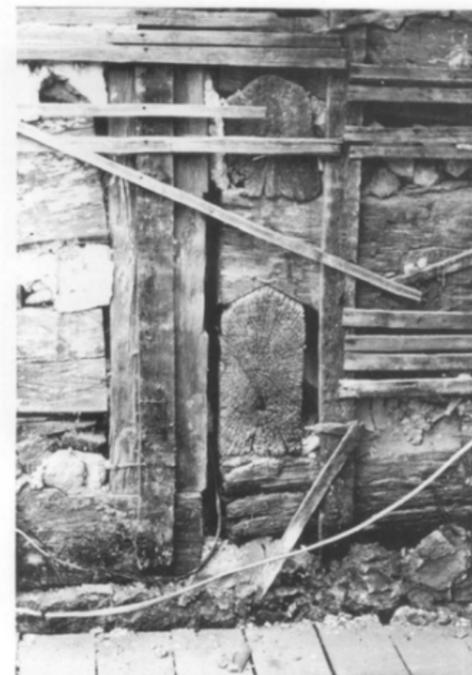
Fig. 8. Removal of deteriorated stucco in preparation for stucco repair on this late-18th century log house in Middleway, West Virginia, reveals that the stucco was applied to hand-riven wood lath nailed over vertical wood strips attached to the logs. Photo: Anne Grimmer.

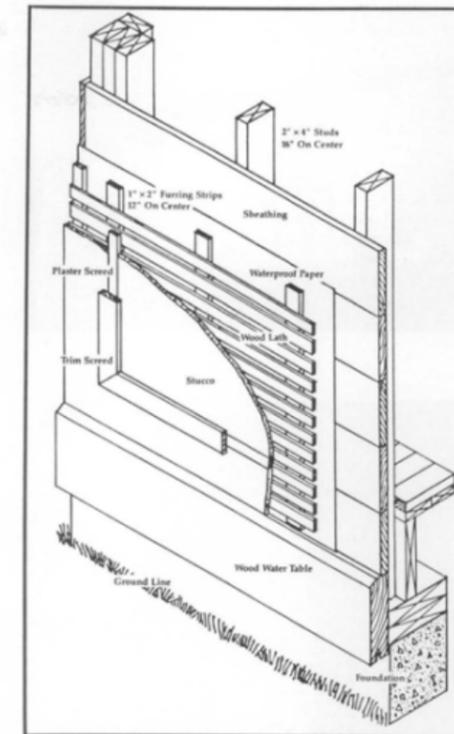
Fig. 9. This cutaway drawing shows the method of attachment for stucco commonly used on wood frame or balloon frame structures from the late-19th to the 20th century. Drawing: Brian Conway, "Illinois Preservation Series Number 2: Stucco."

erosion, and sometimes the bricks themselves were gouged to provide a key for the stucco. This helped provide the necessary bond for the stucco to remain attached to the masonry, much like the key provided by wood or metal lath on frame buildings.

Like interior wall plaster, stucco has traditionally been applied as a multiple-layer process, sometimes consisting of two coats, but more commonly as three. Whether applied directly to a masonry substrate or onto wood or metal lath, this consists of a first "scratch" or "pricking-up" coat, followed by a second scratch coat, sometimes referred to as a "floating" or "brown" coat, followed finally by the "finishing" coat. Up until the late-nineteenth century, the first and the second coats were of much the same composition, generally consisting of lime, or natural cement, sand, perhaps clay, and one or more of the additives previously mentioned. Straw or animal hair was usually added to the first coat as a binder. The third, or finishing coat, consisted primarily of a very fine mesh grade of lime and sand, and sometimes pigment. As already noted, after the 1820's, natural cement was also a common ingredient in stucco until it was replaced by portland cement.

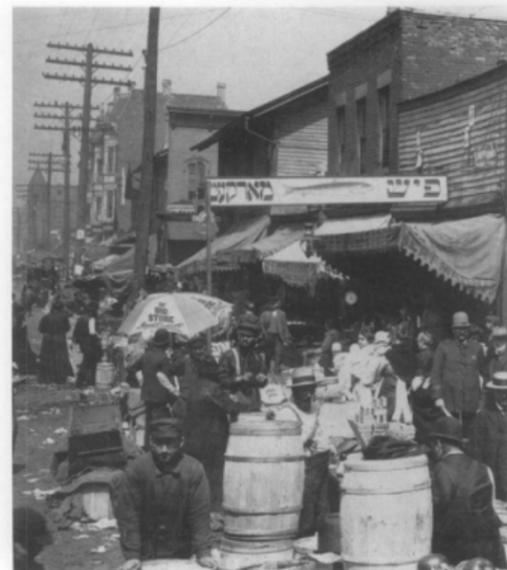
1. Detail from a busy Chicago street market, about 1905. The sign over the sidewalk depicts a fish. It also gives the Hebrew letters for the English words "Fish Market." The sign offers information about the people who patronized the store that is not available from looking at the buildings. They were European Jews who were beginning to learn English. Chicago Historical Society, negative number ICHI-19155.

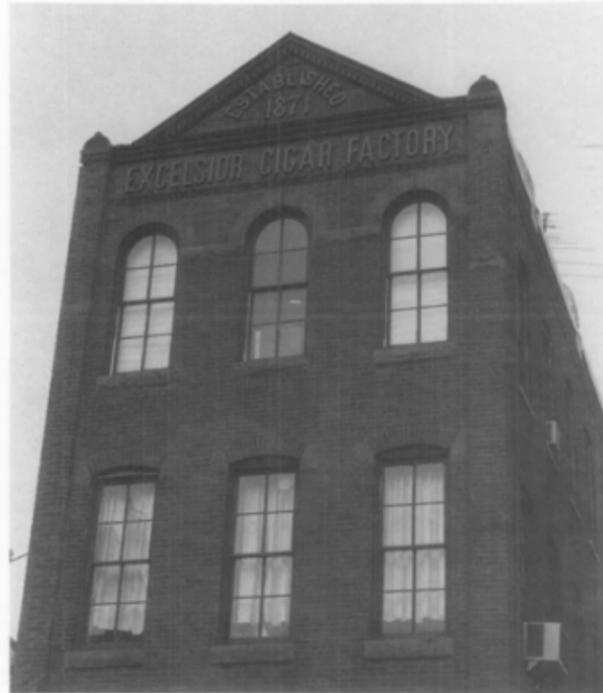
12. The sign on this historic building gives important information about its past. Photo: Thomas C. Jester.

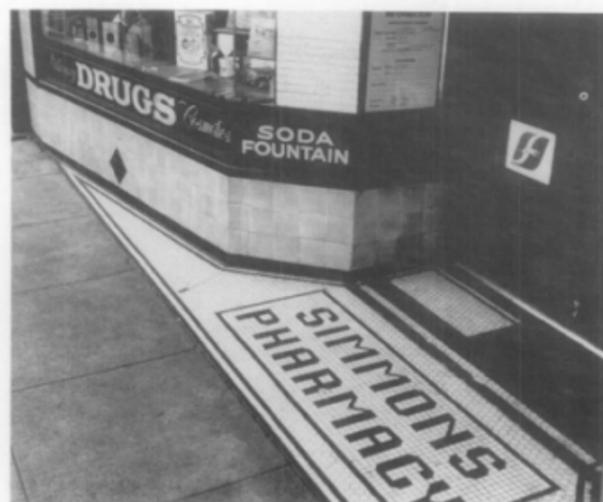
13. Historic signs were often built into a property—and often under foot. Photo: Richard Wagner, National Trust for Historic Preservation.

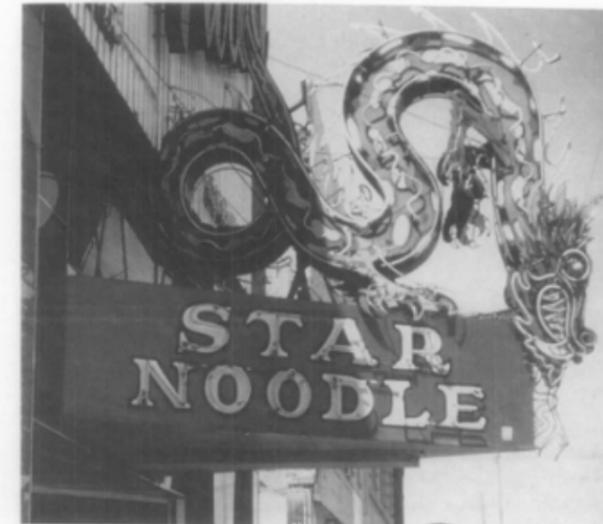
14. This Ogden, Utah, sign is a superb example of neon. Photo: deTeel Patterson Tiller.

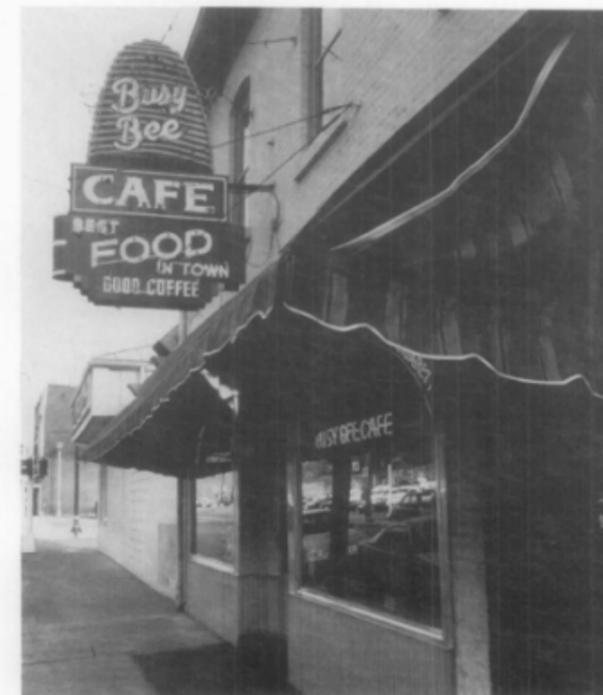
15. The sign for the Busy Bee Cafe is well-known throughout Dubuque, Iowa. Photo: National Park Service, Rocky Mountain Regional Office.

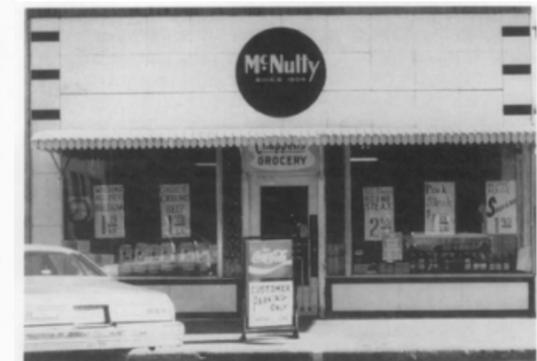
7. In the 1930s and 1940s, signs built into storefronts became popular. This example is from Guthrie, Oklahoma. Photo: H. Ward Jandl.

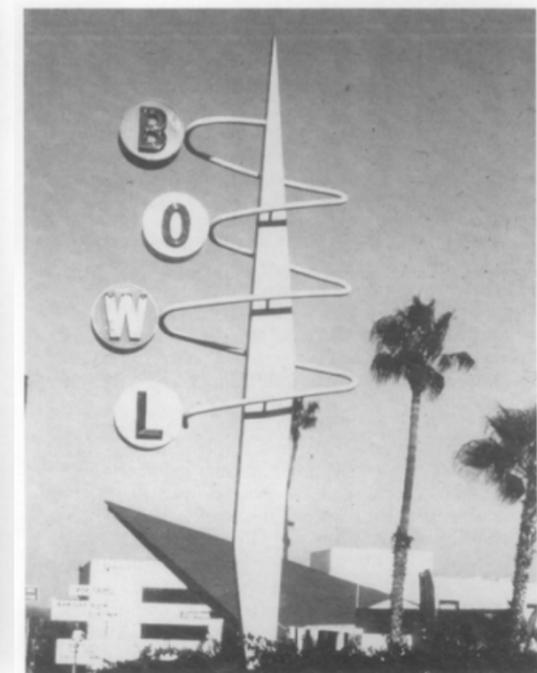
8. In the late 1950s and early 1960s, the country turned its attention to outer space. Wings, fins, and satellite shapes appeared, as in this example in Long Beach, California. Photo: Peter Phillips.
